(21) Report on
OPERATION UPHOT-KNOTHOLE,

Project 3.20(12)

(6) BLAST AND THERMAL EFFECTS
OF AN ATOMIC BOMB ON TYPICAL
TACTICAL COMMUNICATION SYSTEMS (17) (8)

(10) by Jacob Eggert and
Elmer R. Higgins

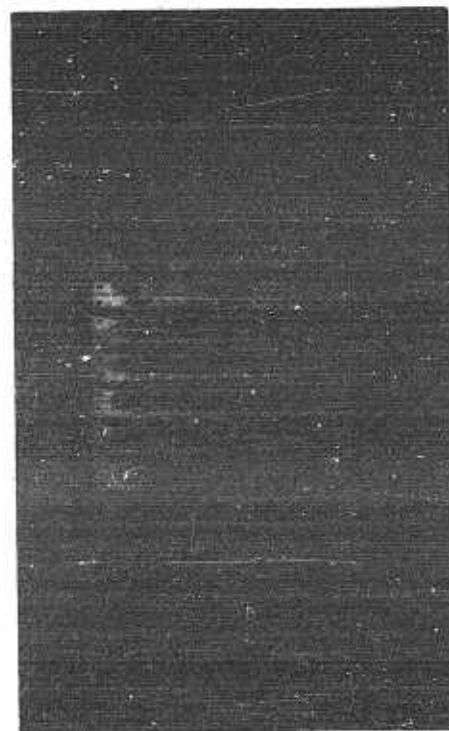
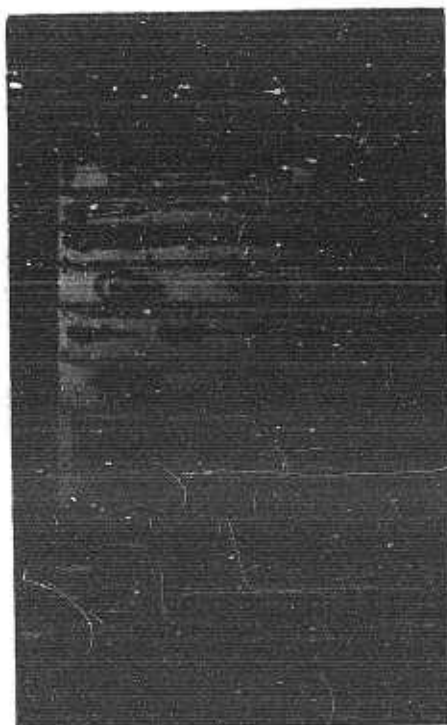
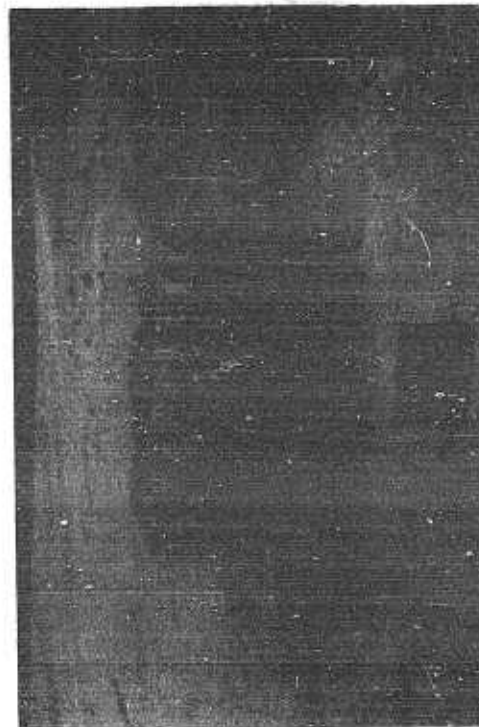
Fig. 3.84 Shot 9, Test Group 98, Exposure Board.
(Top-before, Bottom-after)
8800 ft, 9.5 cal, 3 psi.

Fig. 3.85 Shot 9, Test Group 99, Exposure Board.
(Top-before, Bottom-after)
8800 ft, 9.5 cal, 3 psi

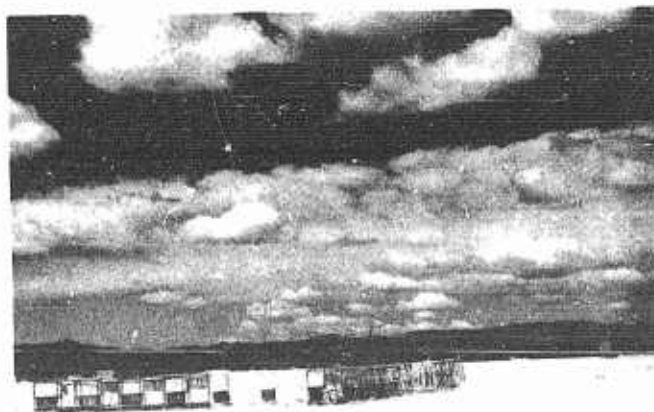
33

b. RESULTS: Severe damage by blast forces. Tower collapsed. Study of high speed photography indicates that basic tower failure occurred between ground and the first guy level. The base and third section from bottom were demolished. Members were severely bent or broken. Adjustable feet at base section were severed. Examination of individual tower sections revealed that only 5 sections could be reused. Fifteen sections were sufficiently damaged to require replacement. Small diagonals (1 inch diameter tubing) in many of the damaged sections failed in either tension or compression. The tensile failure caused the two rivets to be sheared at either end of the diagonal. The compression

Fig. 3.86 Shot 9, Test Group 33, Tower, 120 ft.
(Top-before, Bottom-after)
3350 ft, 51.5 cal, 9.8 psi.

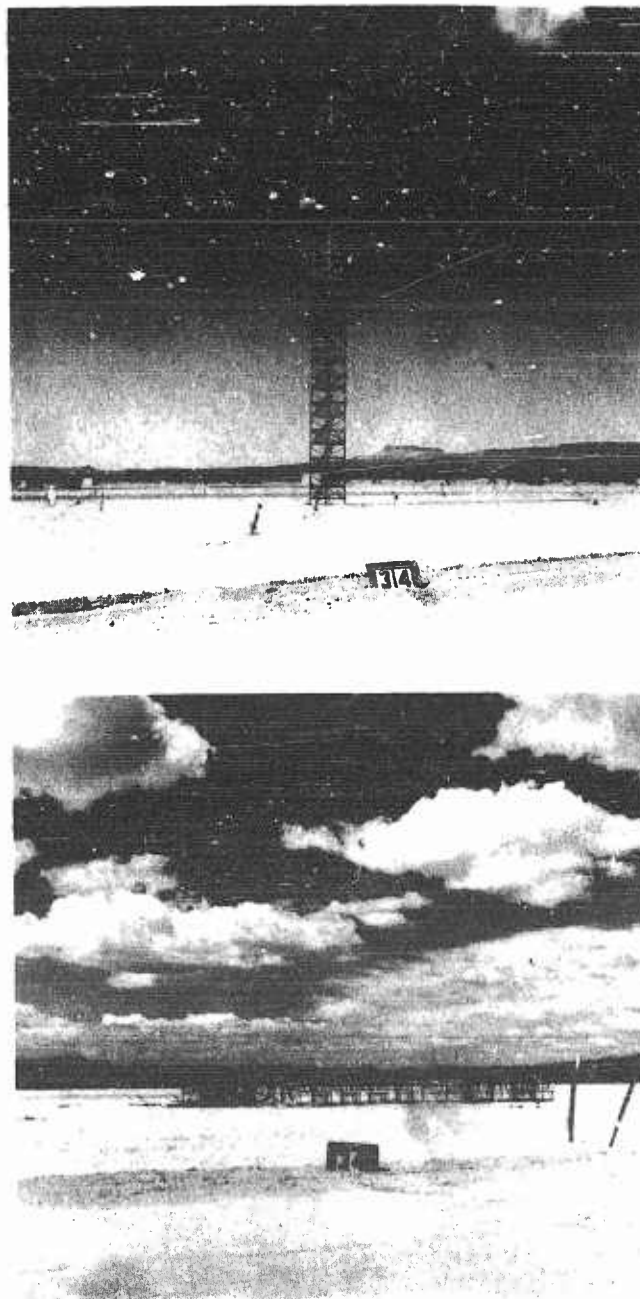
Fig. 3.88 Shot 9, Test Group 34, Tower, 120 ft.
(Top-before, Bottom-after)
4350 ft, 36 cal, 7.2 psi.

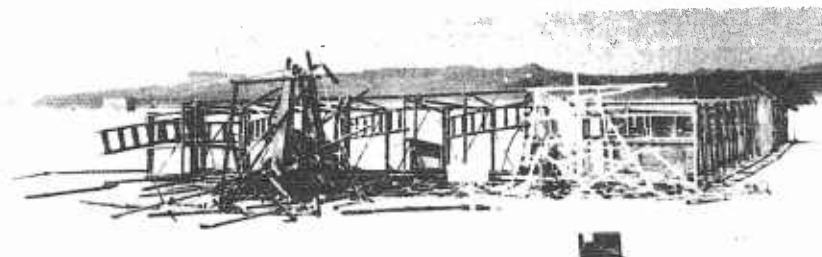
Fig. 3.89 Shot 9, Test Group 34, Tower, 120 ft.
(All after Photos Showing Damage Details.)
4350 ft, 36 cal, 7.2 psi.

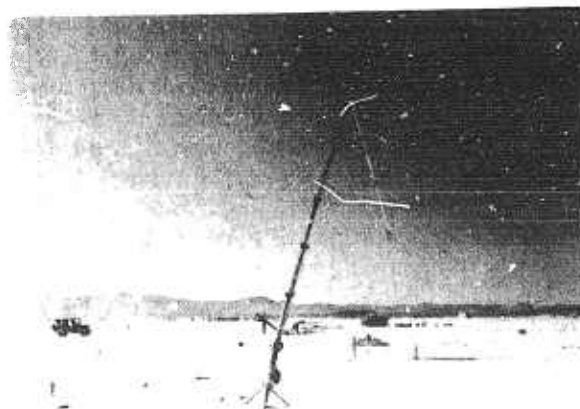
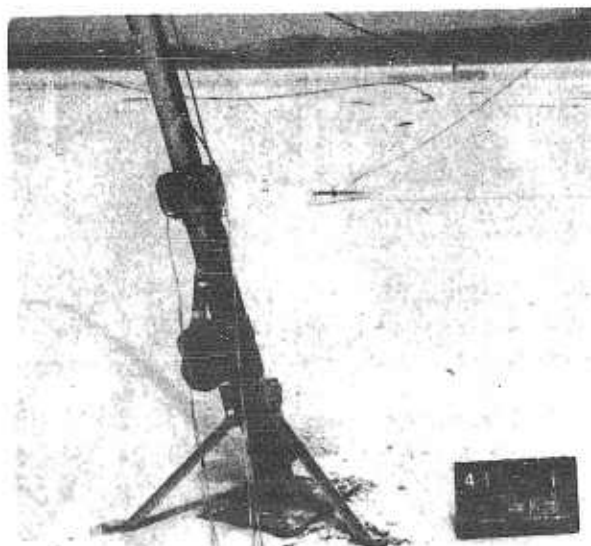
Fig. 3.96 Shot 9, Test Group 41, Antenna Mast AB-224/U. (Top Left-before, Top right-after; Center Close-up of Antenna Base-after) 4625 ft, 32.5 cal, 6.8 psi.

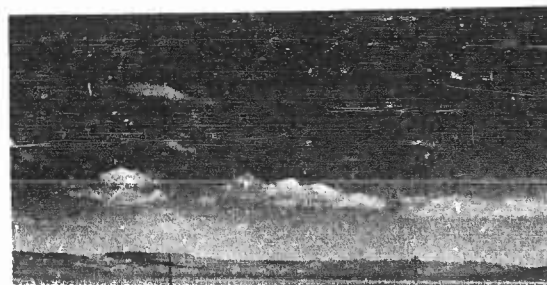
Fig. 3.98 Shot 9, Test Group 43, Antenna System, AS-19/TRC-1.
(Top left-before, Top right-after, Bottom left, bent
Mast-after, Bottom Right-Broken Top of Mast)
4900 ft, 29.5 cal, 6.2 psi.

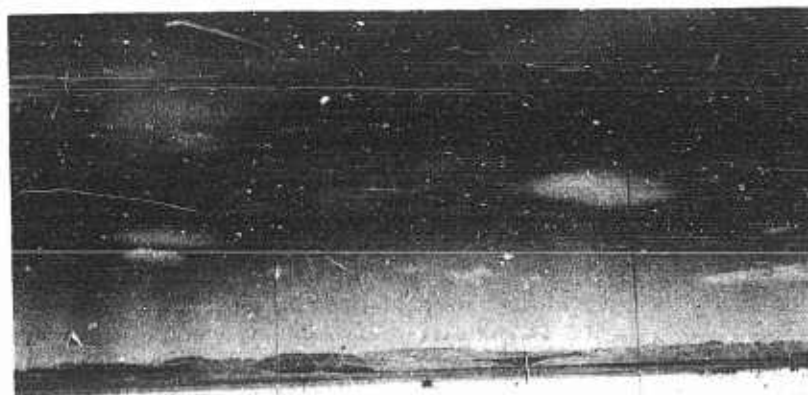
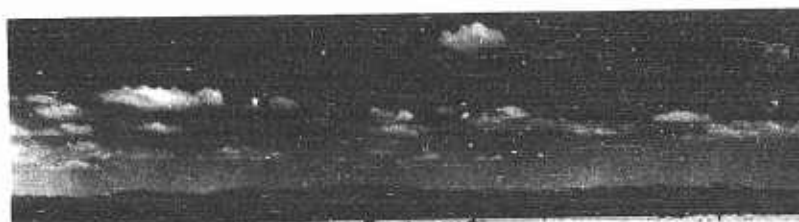
(1) Test Group 47 - located 5000 ft from GZ. The antenna system received severe damage from the blast forces. Both masts collapsed. Several guys failed on both mast installations. Stakes remained in position. The fiberglass base insulators were undamaged by blast or thermal forces. Light thermal damage to the dacron guy surfaces which faced the blast center. Fusing on guy surfaces less than for the nylon guys at same distance from the blast center. The masts were not serviceable.

Fig. 3.102 Shot 9, Test Group 47, Antenna System AN-GRA-4.
(Top-before, Center-after, Bottom-after)
5000 ft, 28.5 cal, 6 psi.

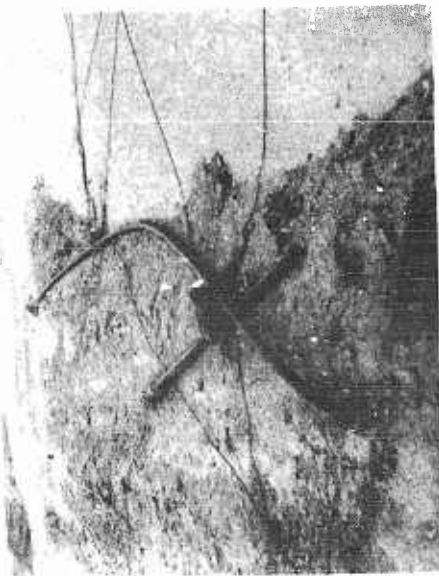
(2) Test Group 48 - located 5000 ft from GZ. The antenna system received severe damage from the blast forces. Both masts collapsed. All guys, guy stakes, hardware items, and the antenna remained intact and reusable. The fiberglass base insulators were undamaged by the blast forces or the thermal radiation. Antenna system was not serviceable. Light thermal damage to the nylon guy surfaces which faced the blast center. Slight fusing was more than for the dacron guys at the same distance from the blast center.

Fig. 3.103 Shot 9, Test Group 48, Antenna System AN/GRA-4. (Top left-before, Top right-after, Bottom left-after, Bottom right-after.) 5000 ft, 28.5 cal, 6 psi.

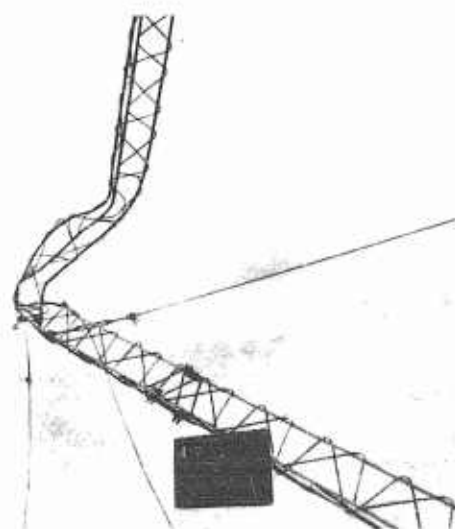
Fig. 3.104 Shot 9, Test Group 49, Antenna Mast AB-26/CR. (Top left-before, Top right-after; Bottom left, Section of Twisted and Broken Mast-after; Bottom right, Reflector-after.) 5550 ft, 25 cal, 5.4 psi.

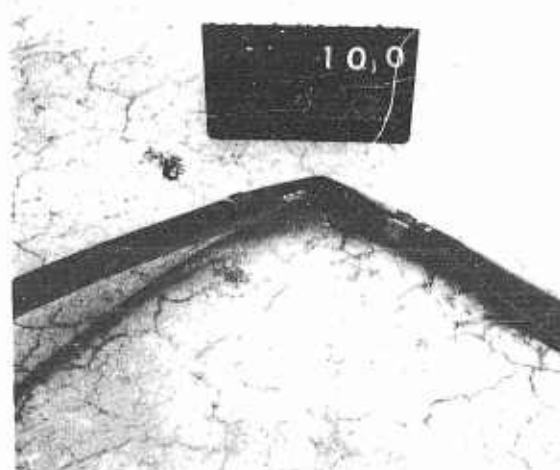
Fig. 3.110 Shot 9, Test Group 100, Antenna System AS-19/TRC-1.
(Top left-before, Top right-after; Bottom left,
Antenna base-after; Bottom right, Bent Mast Section-
after.) 6350 ft, 19.5 cal, 4.6 psi.

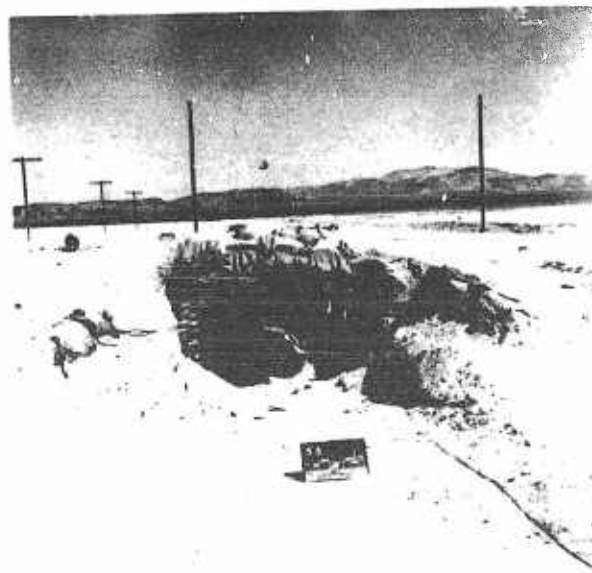
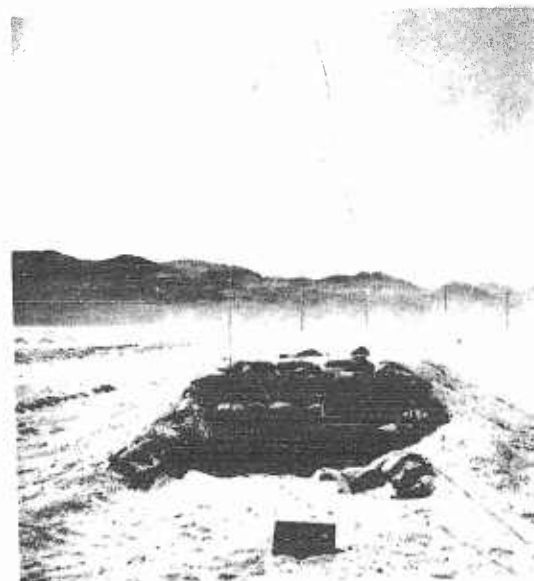
Fig. 3.111 Shot 9, Test Group 55, AN/GRC-26 Radio Set (Revetted).
(Top left-before, Bottom left-after, Top right, Side
View-after, Bottom right, Rear View-after.) 1700 ft,
91 cal, 13.8 psi, 3600 r at Surface, 572 r in S-56
Shelter.

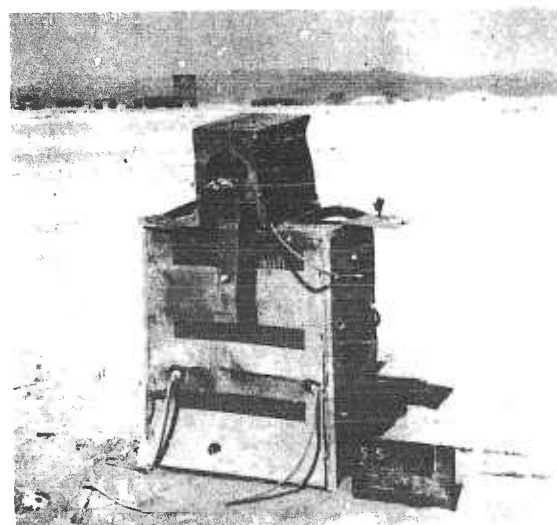
Ruggedized Meter in AN/GRC-26 Transmitter

Fig. 3.113A Shot 9, Test Group 55, AN/GRC-26 Radio Set Detail Photos - All Photos after Shot. Top left, interior of S-56 Shelter; Bottom left, ruggedized Milliammeter in BC-610 Transmitter; Top right, BC-610 Transmitter after Removal from S-56 Shelter, Front View. 1700 ft, 91 cal, 13.8 psi.

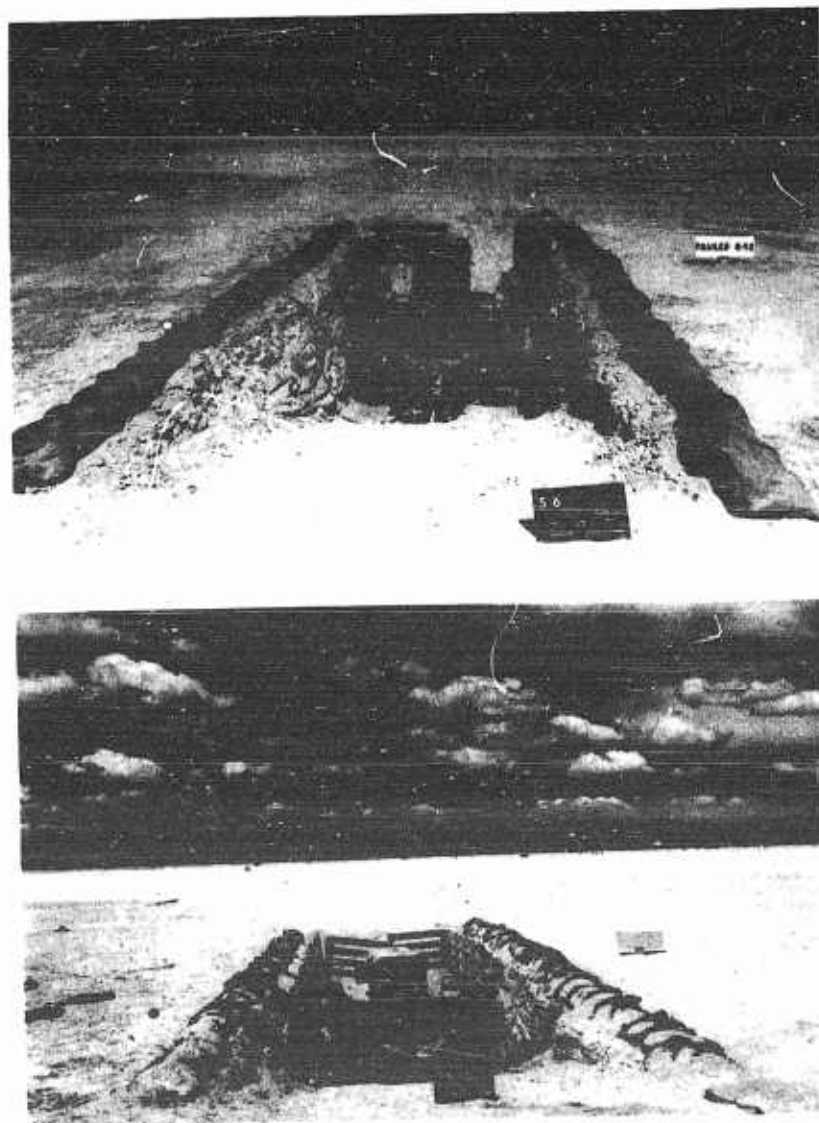
Fig. 3.115 Shot 9, Test Group 56, PE-95 Power Unit, Part of AN/GRC-26 Radio Set (In Open Ended Pit). (Top-before, Bottom-after) 3500 ft, 49 cal, 9.4 psi.

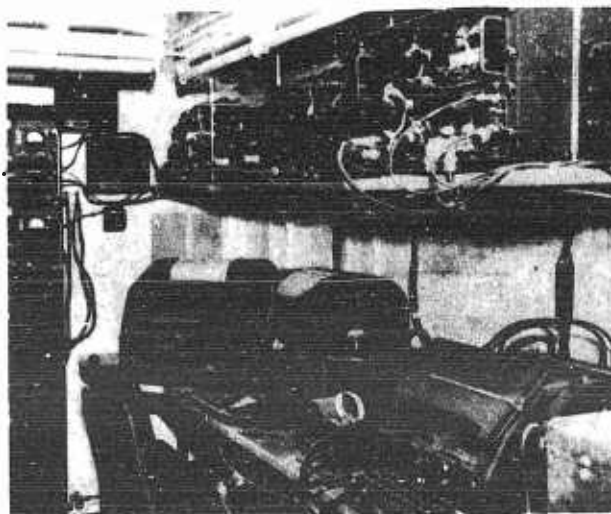
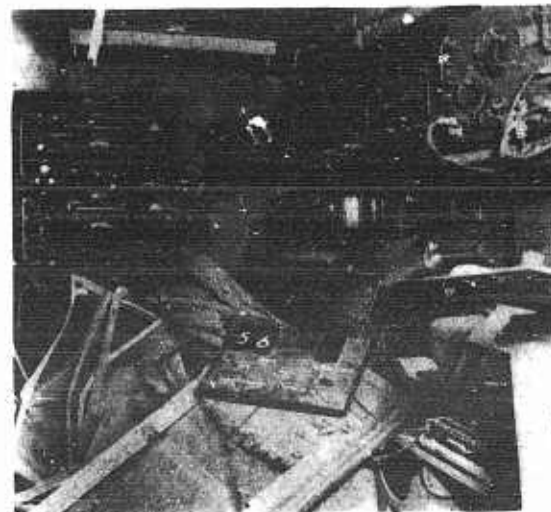
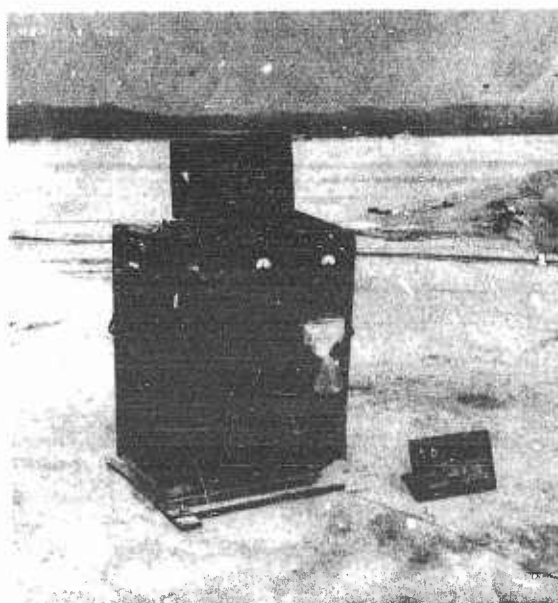
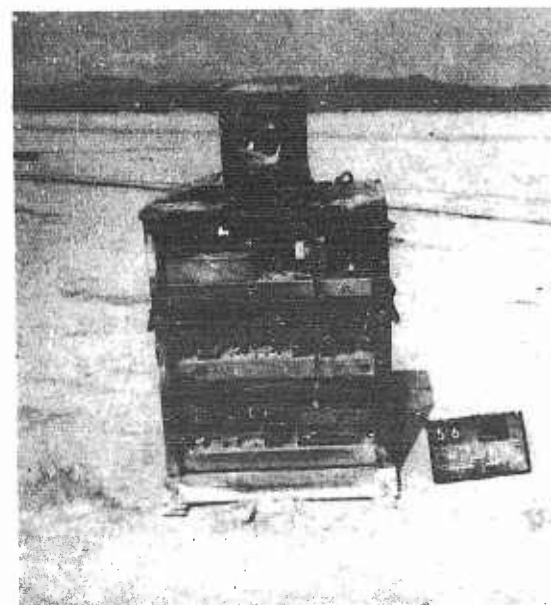
Fig. 3.116 Shot 9, Test Group 56, AN/GRC-26 Radio Set Detail Photos (After).
Top left, interior of S-56 Shelter before blast; lower left, BC-610 Transmitter, front view; bottom right, BC-610 Transmitter, rear view, panel removed; top right, shelter interior after blast. 3500 ft, 49 cal, 9.4 psi, 840 r at surface, 316-168 r in shelter.

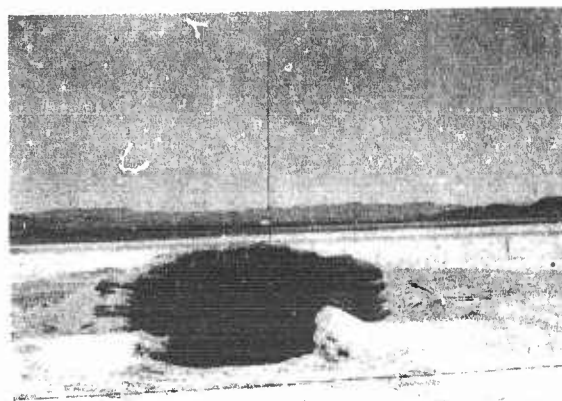
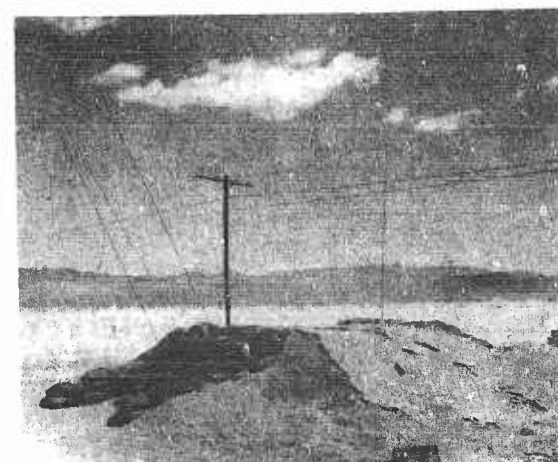
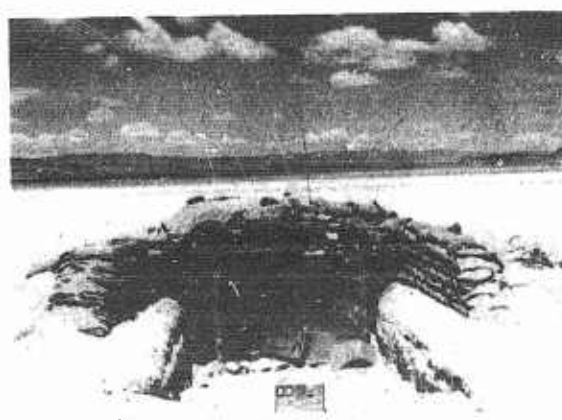
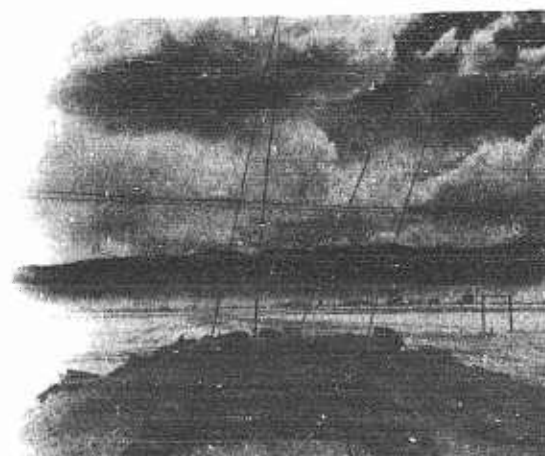
Fig. 3.119 Shot 9, Test Group 58, AN/GRC-26 Radio Set. (Top left-before, Bottom left-after; Top right, rear view-before, Bottom right, rear view-after) 5500 ft, 25 cal, 5.6 psi, 80 r at Surface, 44 r in S-56 Shelter.

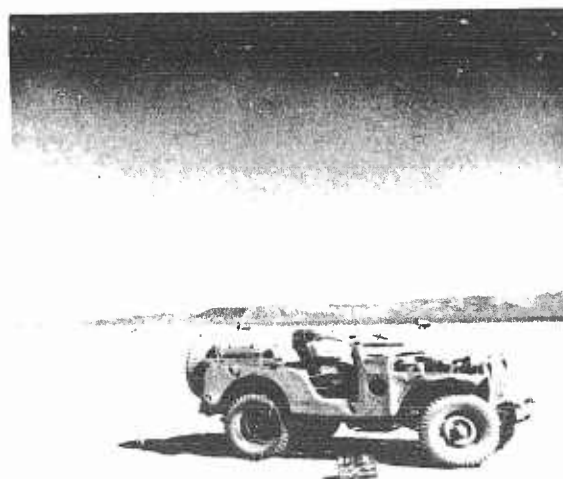
Fig. 3.121 Shot 9, Test Group 80, AN/GRC-9 Radio Set in Ordnance Corps Jeep. (Top left-before, Bottom left-after; Top right-before, Bottom right-after) 1650 ft, 94.5 cal, 14 psi, 368 r at Surface.

Test Group No.	Ft from GZ	cal	psi	Surface Gamma	Interior Gamma	D A M A G E			Remarks
						Thermal	Blast	Gamma	
AN/GRC-9 Radio Sets									
80*	1650	94.5	14	3680	Not applicable	L	L	S	Chassis scorched, calibration charts burned. Antenna bent, some external connections broken. Case of PE-237 power pack dented and top loose. Set operative after minor repairs made. Gamma alone would cause 100% deaths to operating personnel.
81*	2425	58.5	10.6	2280	Not applicable	N	L	S	No thermal damage. Antenna bent and some external connections broken. Set operative after minor repairs. Gamma radiation alone would have caused 100% deaths to operating personnel.
82*	4550	33.5	6.9	200	Not applicable	N	L	M	No thermal damage. Antenna bent and some external connections broken. Set operative after minor repairs. Gamma alone not expected to cause any deaths. No immediate evacuation.

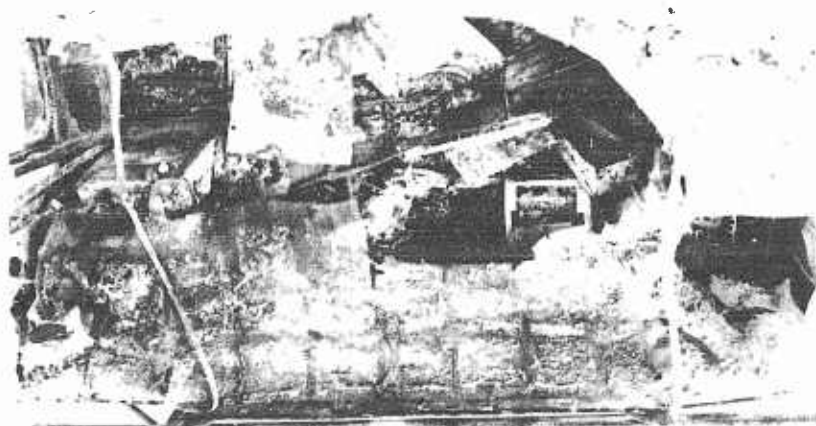
Fig. 3.122 Shot 9, Test Group 81, AN/GRC-26 in Ordnance Corps 2-1/2 Ton Truck. (Top-before, Center-after, Bottom, Interior of AN/GRC-26 Radio Set-after) 2425 ft, 58.5 cal, 10.6 psi, 2280 r at Surface, Interior Gamma Radiation not Known.

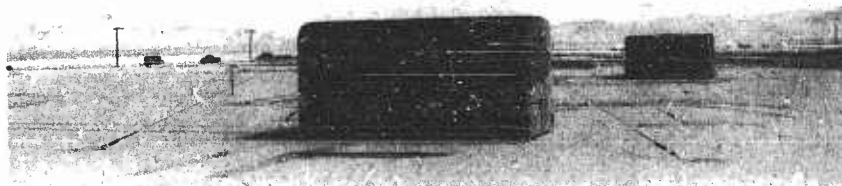
b. RESULTS: The thermal damage to all shelters was light to none. All shelters received severe blast damage. Reference should also be made to Section 3.10 which contains a damage summary of the damage to AN/GRC-26 radio sets housed in S-56 type shelters. A damage summary of these test groups is shown in Table 3.18.

Fig. 3.126 Shot 9, Test Group 60, Shelter S-56 Modified. (Top-before, Second-after, Left, Side-after, Right, Rear-after, Bottom, Front-after) 3050 ft, 57.5 cal, 10.4 psi, 1480 r at Surface.

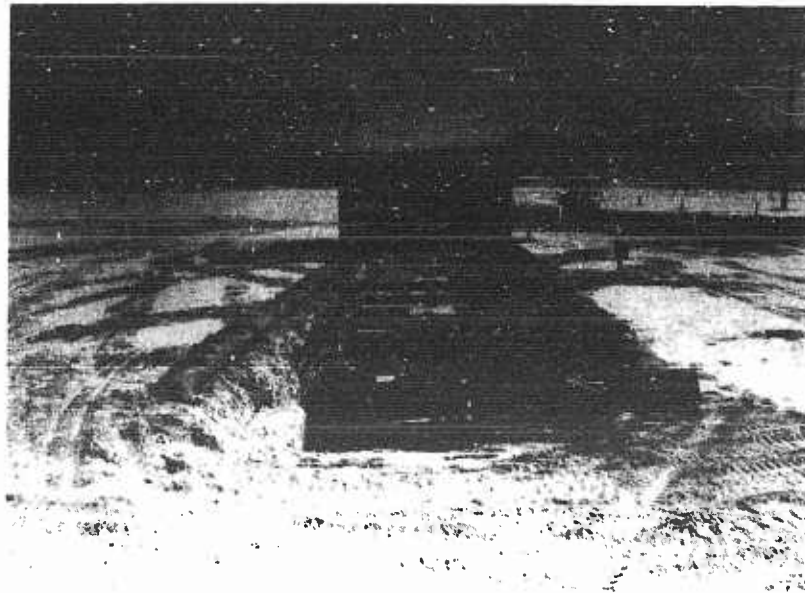
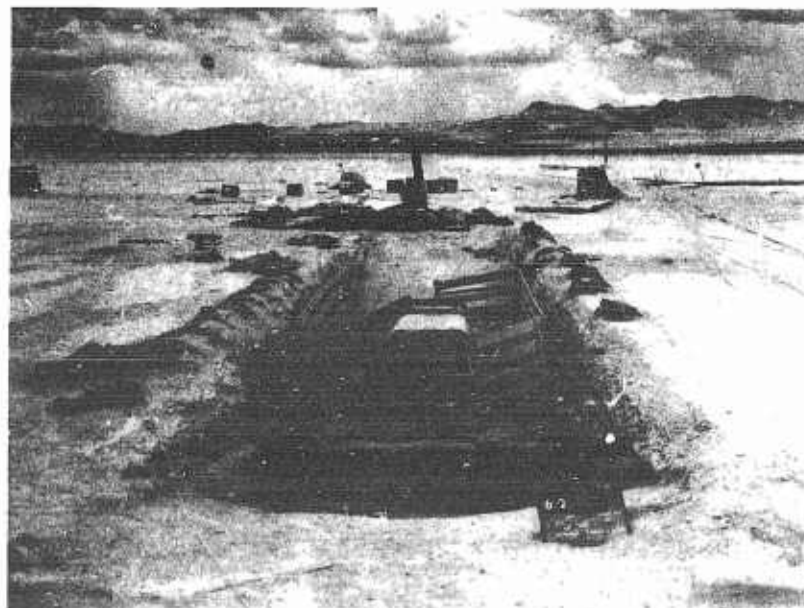
Fig. 3.129 Shot 9, Test Group 62, PE-95 Power Unit in K-52 Trailer in Open Pit Normal to Ground Zero. (Top-before, Bottom-after) 3650 ft, 46 cal, 9.0 psi.

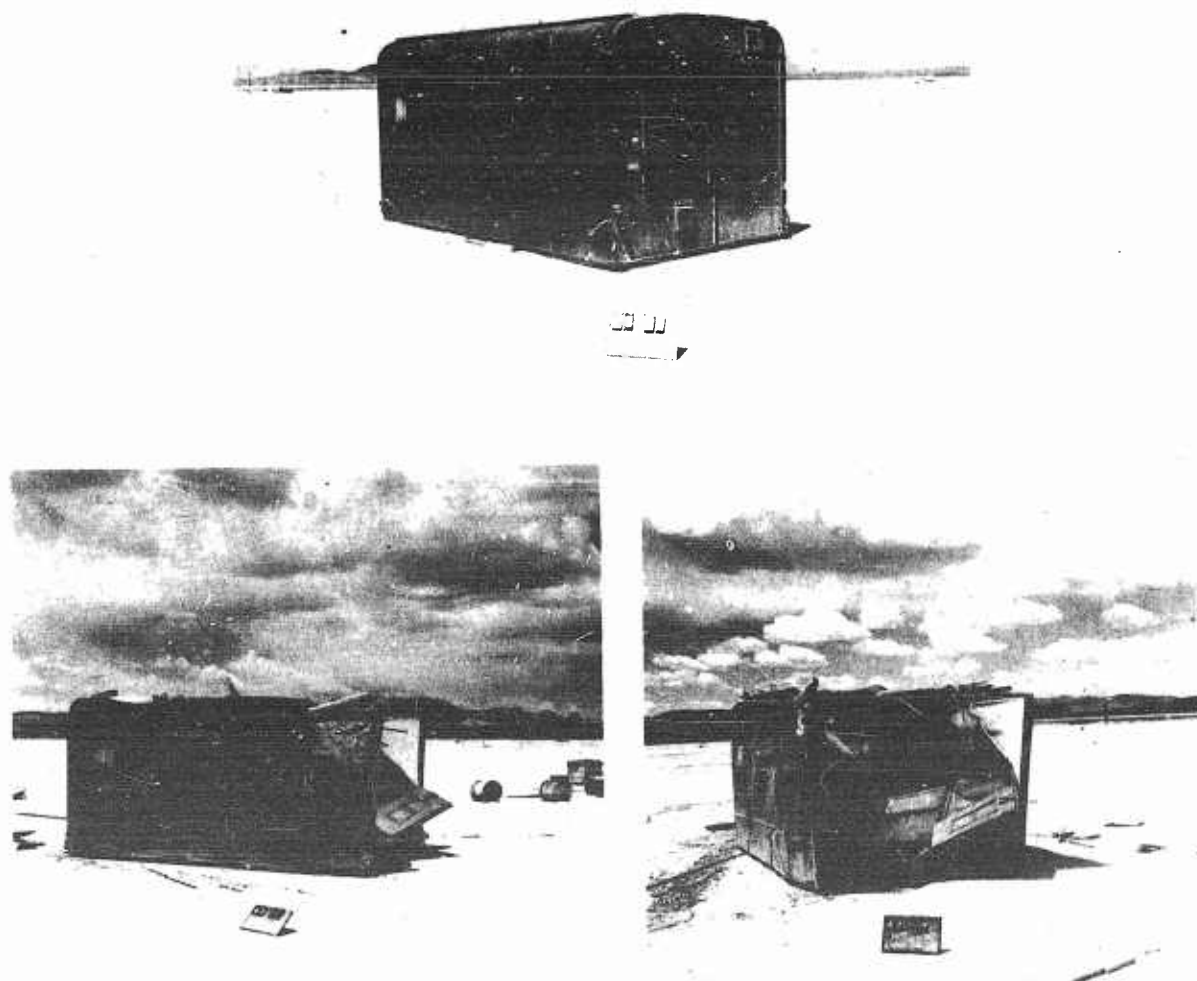
Fig. 3.130 Shot 9, Test Group 63, Shelter S-56. (Top-before, Bottom left-after, Side View, Bottom right-after, Front View)
4650 ft, 32.5 cal, 6.6 psi, 160 r at Surface.

82***	4550	33.5	6.9	200	L	S	Exposed surfaces scorched. Front blown in, top and sides crushed in beyond repair.
63	4650	32.5	6.6	160	N	S	Front blown in, top demolished, sides crushed, beyond repair.
64	5625	24	5.4	80	N	S	Front blown in, top blown in, one side crushed in, one side caved out, blown about 5 ft from original position, beyond repair.

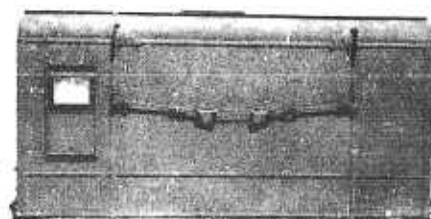
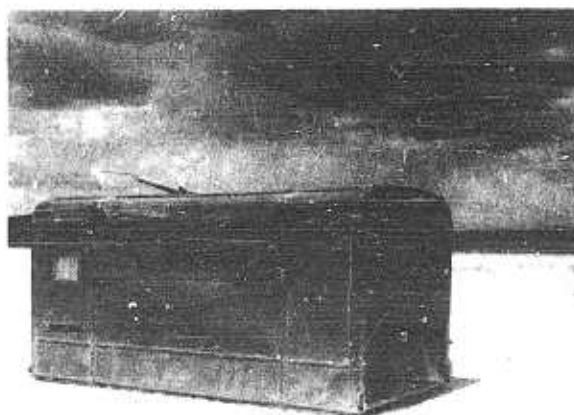
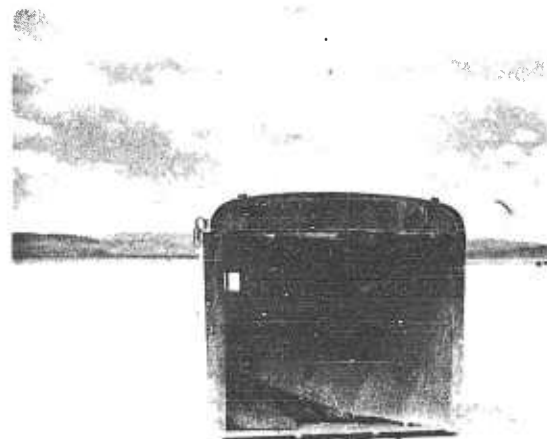
Fig. 3.131 Shot 9, Test Group 64, Shelter S-56. (Top-before, Bottom left-after, Side View, Bottom right-after, Front View)
5625 ft, 24 cal, 5.4 psi, 80 r at Surface.

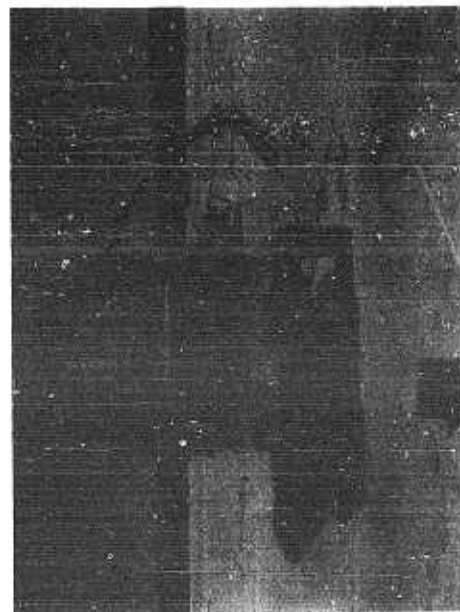
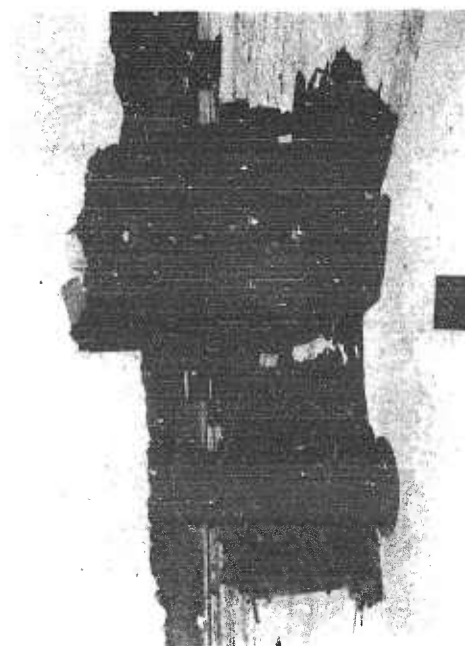
Fig. 3.132 Shot 9, Test Group 80, S-56 Shelter on Ordnance Corps 2-1/2 Ton Truck.
(Top-before, Bottom left-after, Bottom right-after, Front View)
1650 ft, 94.5 cal, 14 psi, 3680 r at Surface.

Test Group No.	Ft from GZ	cal	psi	Surface Gamma	D A M A G E		Remarks
					Thermal	Blast	
80*	1650	94.5	14	3680	L	S	Paint scorched on exposed exterior portions of shelter. Front end of shelter and door blown in, frame twisted, damaged beyond repair.
59**	2325	72	11.6	2440	N	S	The earth revetment provided adequate protection from thermal flux. The front end of this shelter was blown in and torn to pieces. The film badge failed and the interior gamma radiation is not known.
60	3050	57.5	10.4	1480	L	S	Exposed surface slightly scorched. Back of shelter blown out, shelter torn apart and beyond repair. The film badge not found and interior gamma radiation not known.
61	3100	56	10.4	1400	L	S	Exposed surfaces slightly scorched. Front and back blown out, sides and top crushed, beyond repair. Film badge not found, interior gamma radiation not known.
62	3650	46	9	720	L	S	Exposed surfaces lightly scorched. Shelter completely demolished.

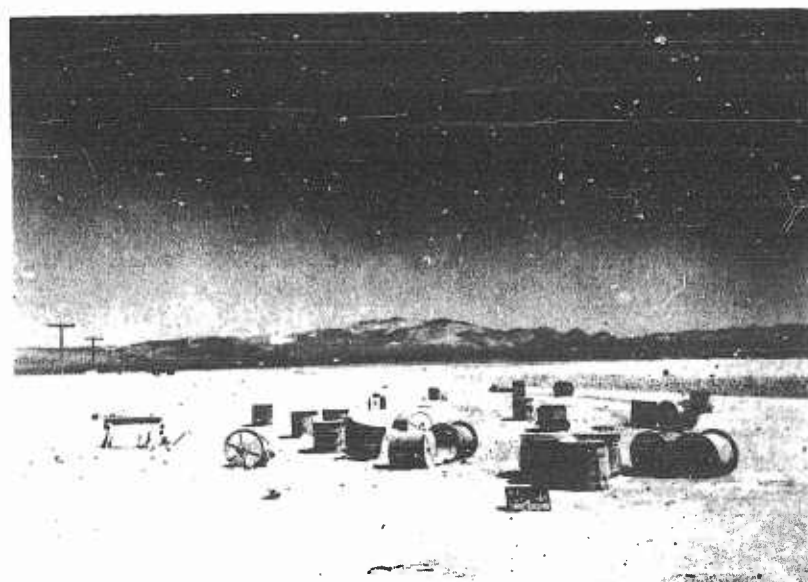
Fig. 3.134 Shot 9, Test Group 65, Signal Supply Point.
 (Top-before, Bottom-after)
 1900 ft, 88.5 cal, 12.8 psi, 3160 r at Surface.

Test Group No.	Ft from GZ	cal	psi	Gamma*	D A M A G E		Remarks
					Thermal	Blast	
65	1900	88.5	12.8	3160	L	L	2WD-1/TT field wire dispensers lightly scorched on GZ side. Cable reels scattered and blown from 40 to 120 ft from original position. One PE-75 packing crate broken, light damage to PE-75 power unit.
66	3150	55	10.2	1160	S	L	Several wire and cable reels caught fire and burned completely, others burned through several layers of wire on reels. One TRC-1 Transmitter burned up. Several cable reels scattered. PE-75 packing crate broken, light damage to PE-75 power unit.
102**	3150	55	10.2	1160	N	N	No thermal damage. Some of items in the pit covered with dirt, others moved about, no damage.
67	3650	46	9.0	720	N	N	No thermal damage. Reels scattered about, one PE-75 packing case broken, no damage.
68	4675	32	6.6	160	L	N	One reel W-110-B severely burned, slight scorching on other exposed items. Reels and boxes scattered to 30 ft from original positions, no damage.

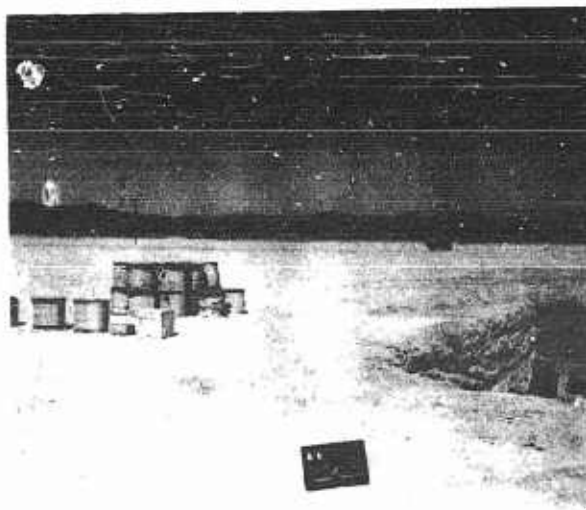
Fig. 3.135 Shot 9, Test Group 66, Signal Supply Point. (Top left-before, Top right-after, Bottom left-Close-up of AN/TRC-1 Transmitter-after, Bottom right-close-up of PE75 Power Unit-after)
NOTE: Signal Supply Point in Open Pit in Top and Center of Photos. 3150 ft, 55 cal, 10.2 psi, 1160 r at Surface.

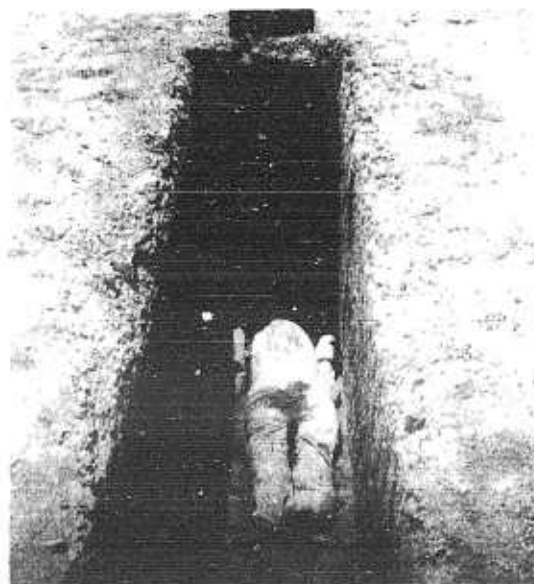
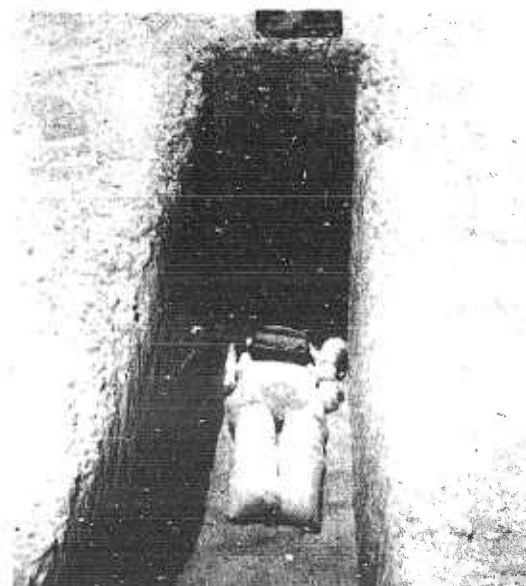
Fig. 3.143 Shot 9, Test Group 71. Foxhole with Radio Set AN/PRC-6 on Dummy. (Top-before, Bottom-after). 2800 ft, 62 cal, 10.8 psi, 1760 r at Surface.

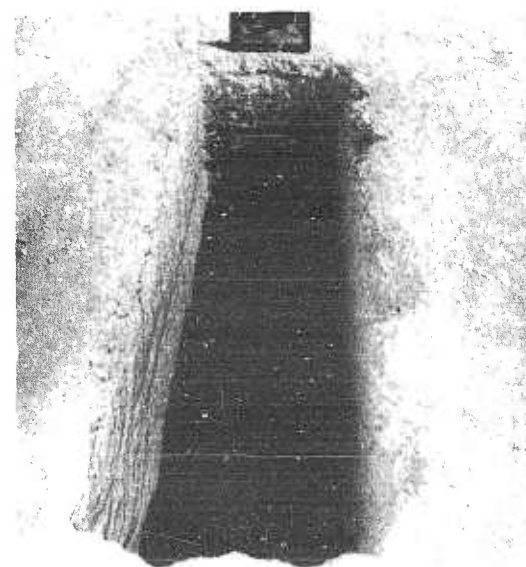
It is of interest to observe that the dummies in foxholes along the radial pole line at 3800 ft, 44 cal, 8.6 psi (Fig. 3.144), and 4800 ft, 30.5 cal, 6.4 psi (Fig. 3.145), did not catch fire and burn. However, the dummy in the foxhole at 5800 ft, 28.5 cal, 5.2 psi (Fig. 3.146), did catch fire and burn. There is no explanation for this phenomenon except that in previous tests the thermal flux has caused no damage at a given ground range from GZ which "skipped" and has caused severe damage beyond the point where no damage occurred. One can also postulate that shielding conditions or the burning point of the materials in this particular dummy (fabric and straw) were such that burned.

Fig. 3.144 Shot 9, Test Group 72. Foxhole with Radio Set AN/PRC-10 on dummy. (Top-before, Bottom-after). 3800 ft, 44 cal, 8.6 psi, 550 r at Surface.

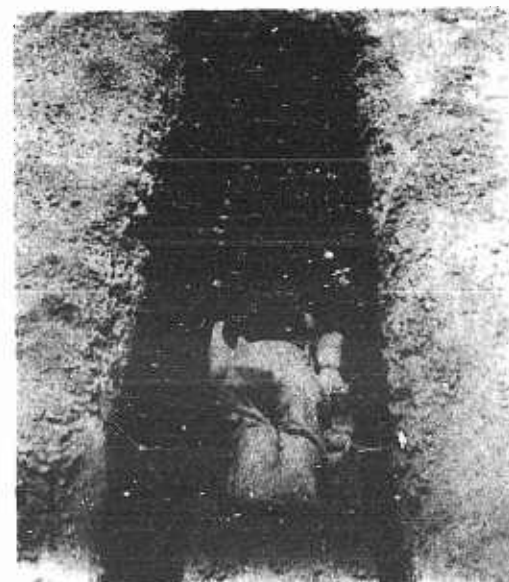
Fig. 3.145 Shot 9, Test Group 73.
Foxhole with Radio Set AN/PRC-6 on
Dummy and EE-8 Telephone in Foxhole.
(Top-before, Bottom-after) Dummy
was Moved to Sitting Position from
Prone Prior to Test. 4800 ft, 30.5
cal, 6.4 psi, 160 r at Surface.

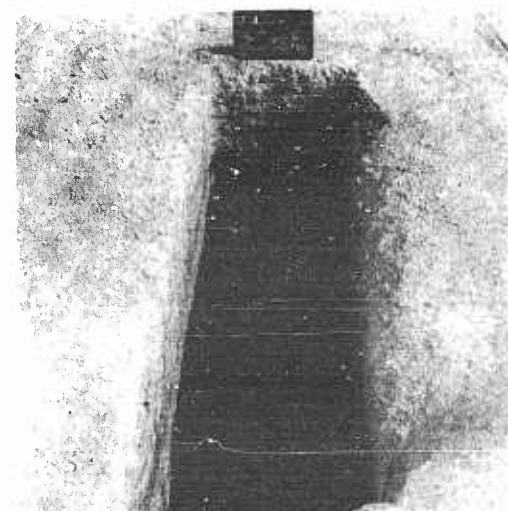
74	5800	28.5	5.2	80	S	N	Dummy caught fire and burned up. One AN/PRC-10 radio set severely burned. One EE-8 field telephone canvas case scorched but telephone not damaged. Some dirt blown in foxhole, no damage.
75	6800	16.5	4.2	20	N	N	Some dirt blown in foxhole, no damage.
76	7800	12	3.5	less than 1	N	N	Some dirt blown in foxhole, no damage.

Fig. 3.146 Shot 9, Test Group 74.
Foxhole with Radio Set AN/PRC-10 and
Dummy and EE-8 Telephone in Foxhole.
(Top-before, Bottom-after) 5800 ft,
28.5 cal, 5.2 psi, 80 r at Surface.

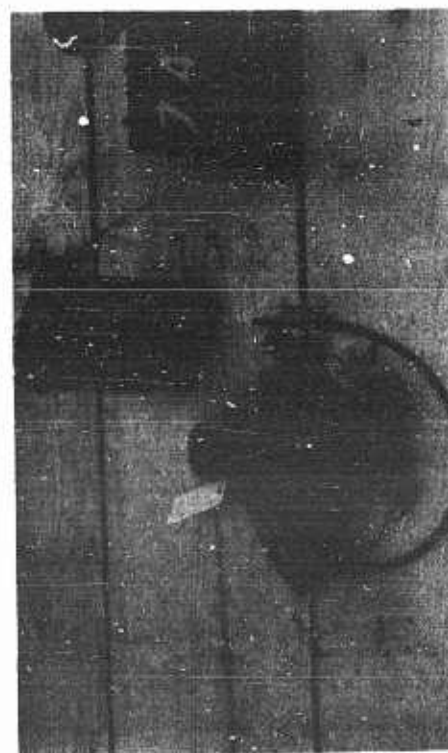
Fig. 3.147 Shot 9, Test Group 74, Radio Set AN/PRC-10 and Telephone Which were in Foxhole (Fig. 3.118).
(Top-exterior, left-interior, Right-EE-8 Telephone)
5800 ft, 28.5 cal, 5.2 psi.

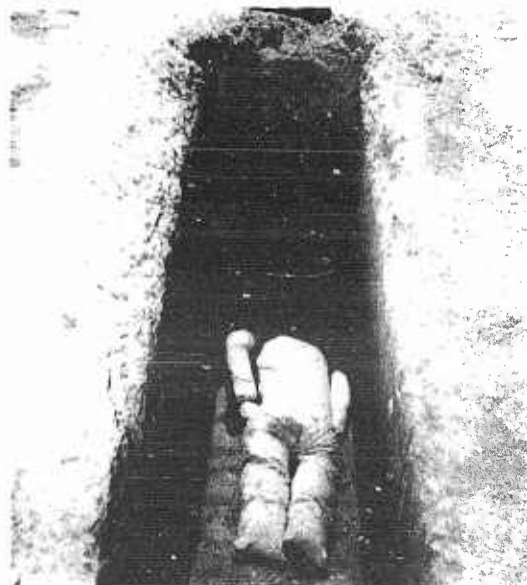
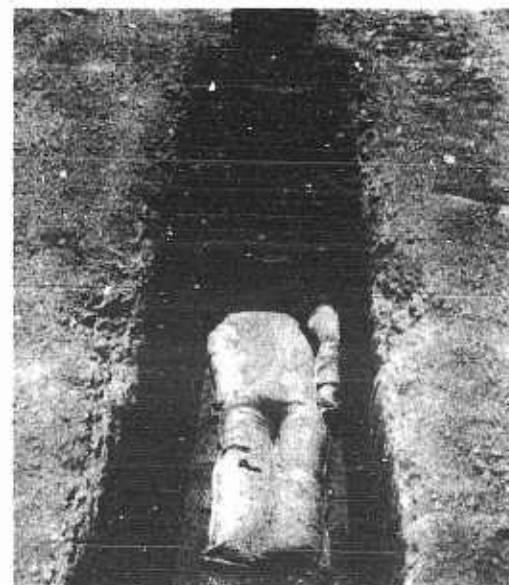
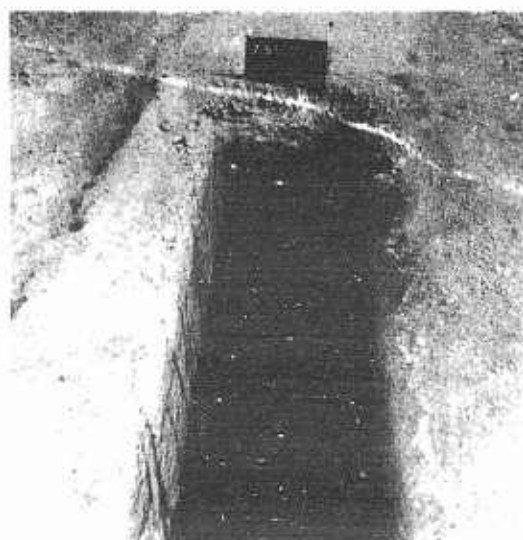
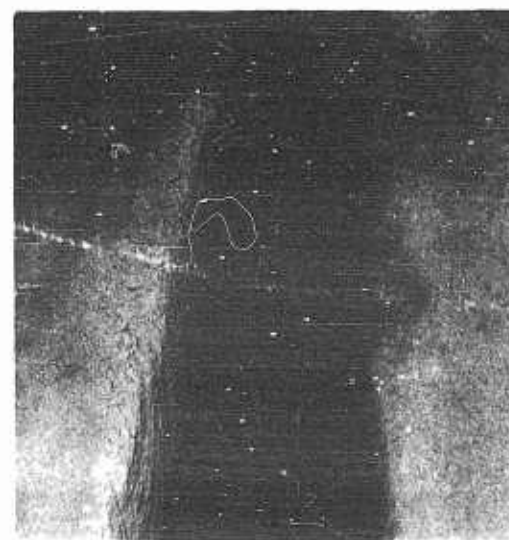
Fig. 3.148 Shot 9, Test Group 75. Foxhole with Radio Set AN/PRC-6 on Dummy and EE-8 Telephone in Foxhole. (Dummy was Moved to Sitting Position Prior to Test.) Top-before, Bottom-after. 6800 ft, 16.5 cal, 4.2 psi, 20 r at Surface.

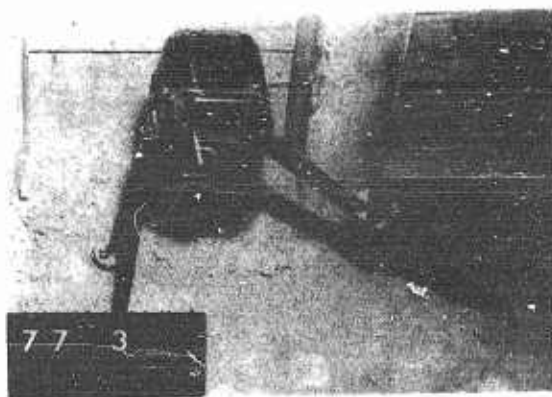
Fig. 3.150 Shot 9, Test Group 77, Signal Corps Items in Corps of Engrs. Installations (CO Type CP). (Top left-before, Top right-after; SB-22 Switchboard, Center left-before, Center right-after; GN-58A Generator, Bottom left-before, Bottom right-after.) 500 ft, over 125 cal, over 21 psi, 6400 r at Surface.

Test Group No.	Ft from GZ	cal	psi	Surface Gamma*	D A M A G E		Remarks
					Thermal	Blast	
77	600	over 125	over 21	6400	N	N	CP shielded from thermal damage. Dust permeated the CP and the equipment, equipment operable.
78	900	over 125	over 21	5400	N	N	CP shielded from thermal damage. Dust permeated CP and the equipment, operable.
79	4000	41	8	400	N	N	CP shielded from thermal damage. Dust permeated CP and the equipment, equipment operable.

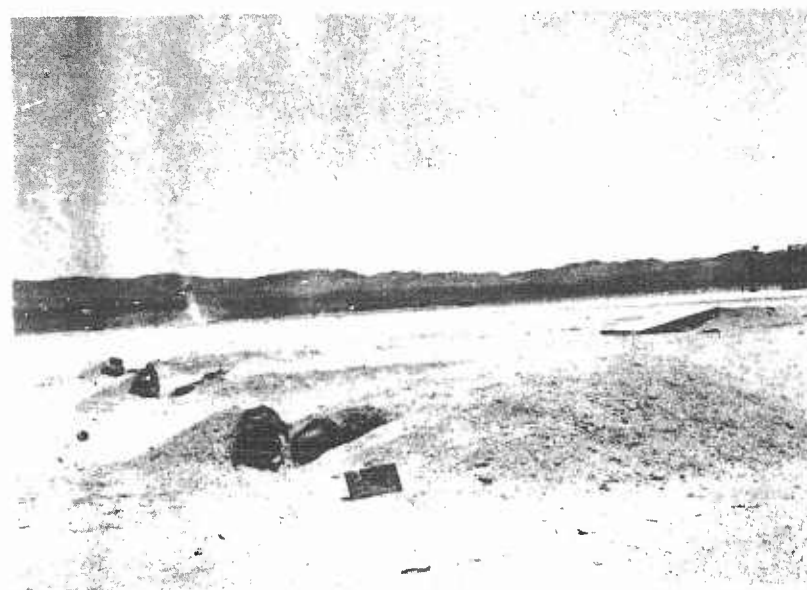
Fig. 3.152 Shot 9, Test Group 79, Signal Corps Items in Corps of Engrs. Installation (CO Type CP). (Top-before, Bottom-after) (See Fig. 3.153 for Equipment.)
4000 ft, 41 cal, 8 psi, 400 r at Surface.

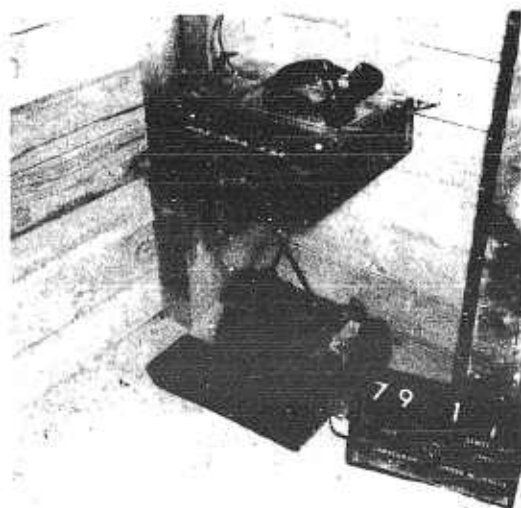
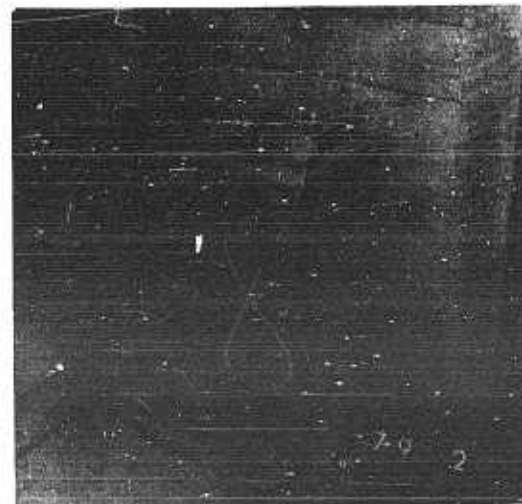
Fig. 3.153 Shot 9, Test Group 79, Signal Corps Items in Corps of Engrs. Installations (CO Type CP-Fig. 3.124). SB-22 Switchboard (Top left-before, Top right-after; GN-94 Generator and EE-8 Telephone (Bottom left-before, Bottom right-after) 4000 ft, 41 cal, 8 psi, 400 r at Surface.

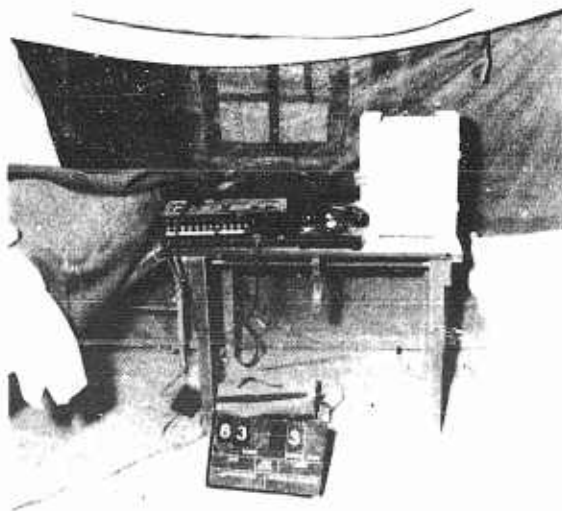
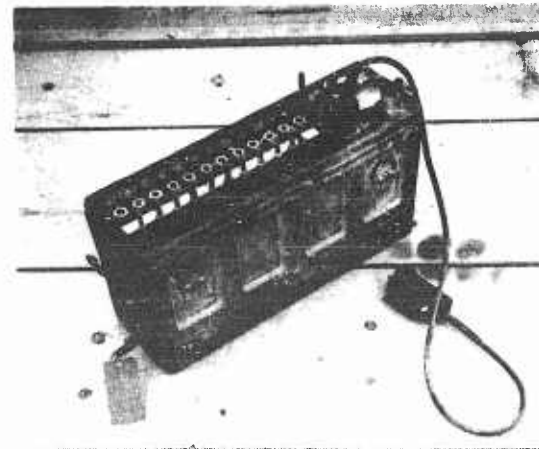
b. RESULTS: The field hospital above and below the surface at 4125 ft, 39.5 cal, 8 psi (Fig. 3.154) caught fire and burned up. An examination of high speed photograph taken during the shot indicates that the heat caused the tent to burn from primary effects. It is extremely doubtful if the telephone equipment in the tent was damaged from primary effects. It is more plausible to believe that the heat from the tent burning caused secondary damage to the telephone equipment. The entire burning cycle is very, very rapid. A damage summary for this test group is shown in Table 3.22.

Fig. 3.154 Shot 9, Test Group 83, Signal Corps Items in Medical Corps Installations. (Field Hospital in Tents at the Surface.) (Top left-before, Bottom left-after; Top right, SB-22 Switchboard-after, Bottom right, close-up of Same Switchboard-after) 4125 ft, 39.5 cal, 8 psi, 320 r at Surface.

Test Item	Ft from GZ	cal	psi	Surface Gamma*	D A M A G E		Remarks
					Thermal	Blast	
IN TENT BELOW THE SURFACE							
SB-22 Switchboard	4125	39.5	8	320	S		Plug melted on bakelite strip, transmitter cord burned up, drop indicators melted. Switchboard thrown to ground.
TP-6 Telephone	4125	39.5	8	320	S	L	Handset, cord, induction coil and condenser completely burned. Telephone thrown to ground.
EE-8 Field Telephone	4125	39.5	8	320	S	L	Handset cord severely burned, terminals button and WD-1/TT wire melted. Telephone thrown to ground.
IN TENT ABOVE THE SURFACE							
SB-22 Switchboard	4125	39.5	8	320	L	L	Spare telephone line circuit severely burned, spare parts kit slightly burned. Thrown 300 ft from original position, one plug slightly damaged battery case out of sockets. Case slightly damaged near ring back key. Serviceable after minor repairs made.
TP-6 Telephone	4125	39.5	8	320	L	L	Slight
EE-8 Field Telephone	4125	39.5	8	320	L	L	Slight

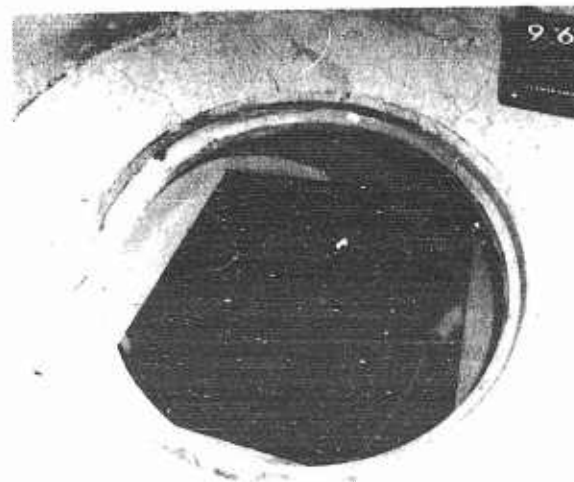
b. RESULTS: The manhole cover in Shot 9 (1250 ft, 113 cal, 16.6 psi), was lifted from its base and moved 1/2 in. There were several

inches of dirt blown into the manhole but there was no apparent damage to the cable transfer relay or cable installed in manhole.

In Shot 10 the manhole cover (600 ft, over 65 cal, over 115 psi), was forced into the manhole and covered with 1-1/2 ft of earth. The manhole (field constructed) was crushed in and filled with 1-1/2 ft

Fig. 3.156 Shots 9 and 10, Test Group 96, Manhole. (Top left-before 9, Bottom left-after 9; Interior of Manhole, Top right-before 9, Bottom right-after 9.) NOTE: The Manhole was destroyed in Shot 10. Shot 9 - 1250 ft, 113 cal, 16.6 psi. Shot 10 - 600 ft, over 65 cal, over 115 psi.

of earth. The concrete tile was intact. There was no cable transfer relay present in the manhole for Shot 10. The cable in the manhole was not damaged.
